Identifying Alternative Strategies for Controlling Biofouling on United States Coast Guard Sector San Juan Vessels

An Interactive Qualifying Project submitted to the faculty of
Worcester Polytechnic Institute
in partial fulfillment of the requirements for the Degree of Bachelor of Science

Sponsoring Agency: United States Coast Guard Sector San Juan

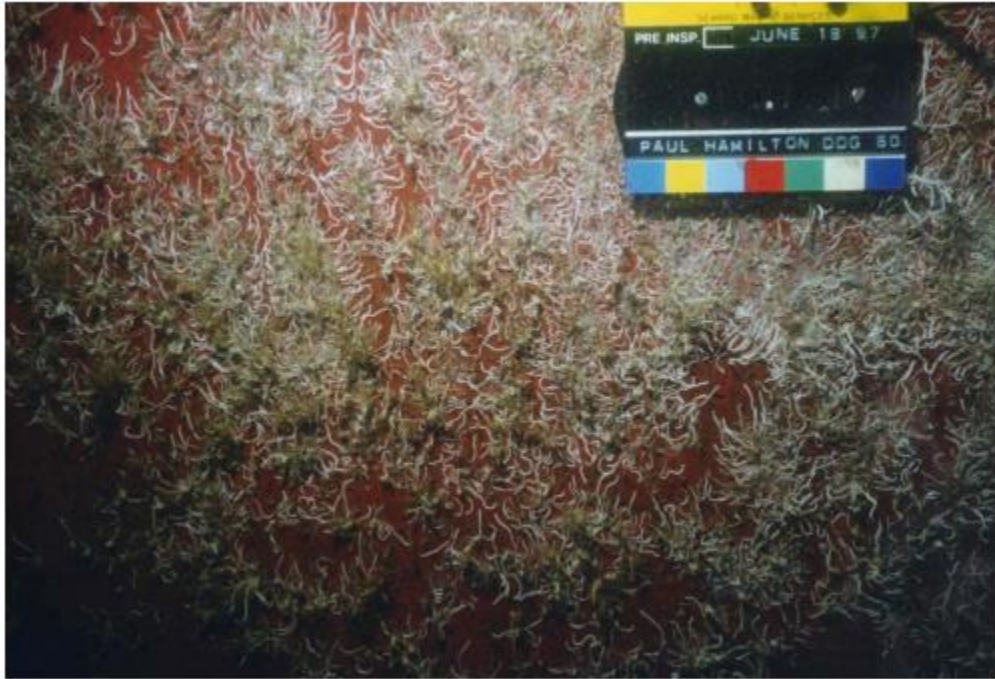
Figure 5 – Predominantly Tubeworms are Abundant on the Hull: FR-40

3. After the completion of the biofilm layer (microfouling), larger species may begin to attach such as barnacle larvae, tubeworms and algae (macrofouling) (Cao et al, 2010).

As seen through Figure 1 and Figure 2, microfouling is difficult to distinguish as species, and is therefore referred to as the biofilm or slime layer. Macrofouling species are more commonly associated with biofouling, as they can be seen easily by the human eye in Figure 3 through Figure 6.

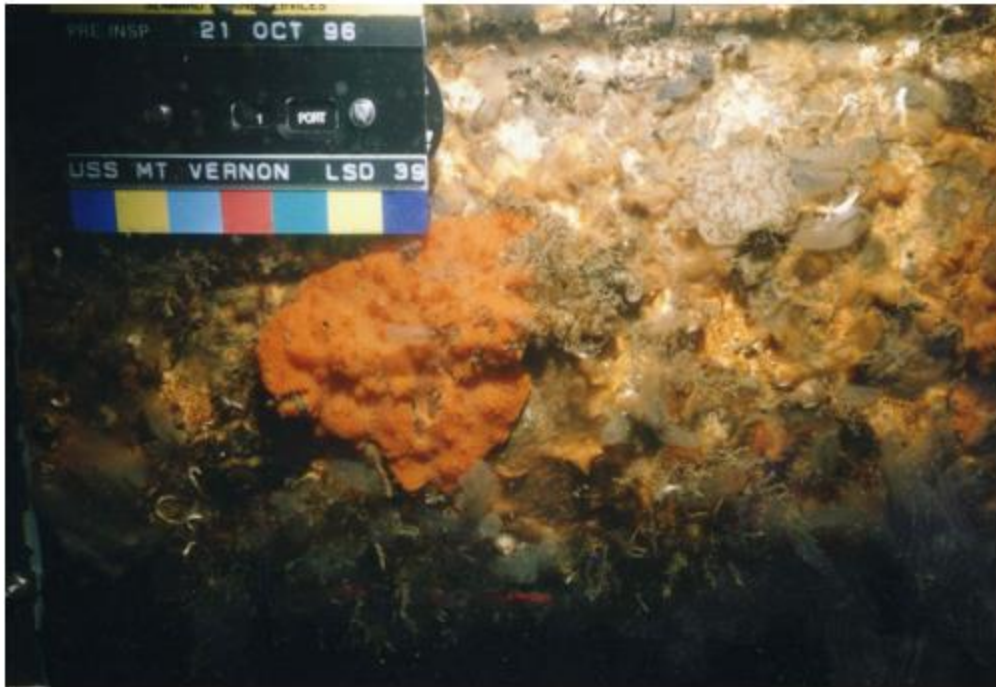
Figure 6 – Composite Biofouling with Many Different Species: FR-100

4. Once macrofouling species begin to attach, they then move to maturity and become much more visible, eventually growing to mask the surface if left untouched (Cao et al, 2010).

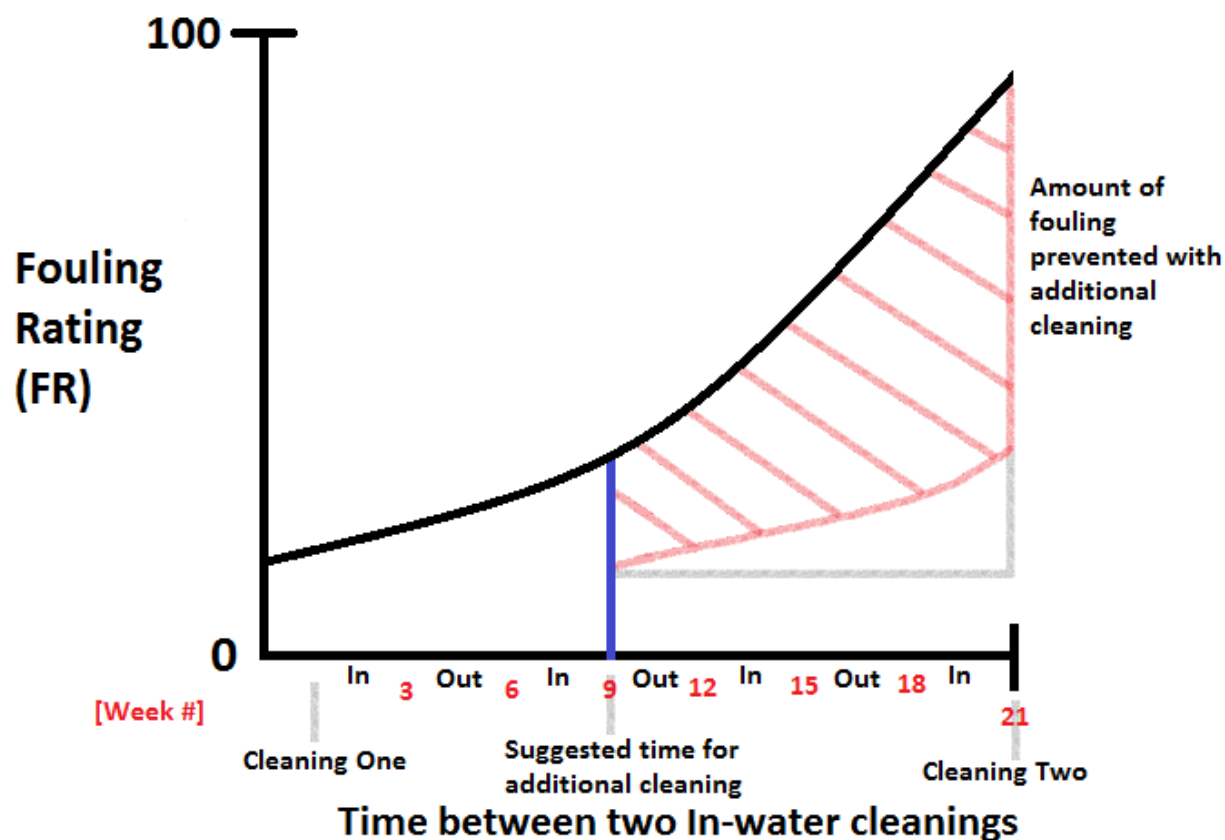
Figure 13 – Biofouling Accumulation Graph

Once the data is collected, it can be plotted over time according to Figure 13 below. Based upon the process of biofouling, we anticipate that the actual chart will show an exponential growth/acceleration of the biofouling accumulation. From this chart, one can set a "sliding" cleaning interval, and see at a given time (using integration of the area under the curve) how much biofouling accumulation can be avoided with an added cleaning.

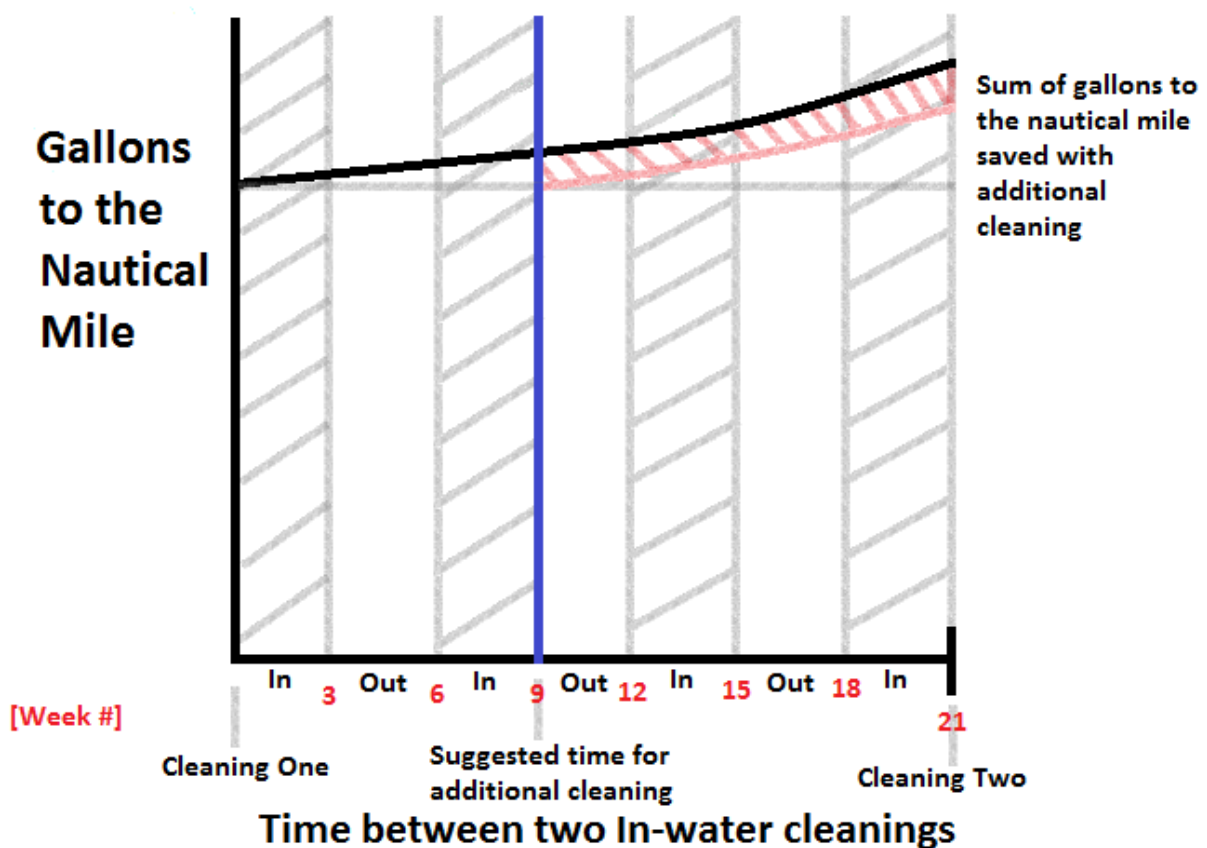
Figure 16 – Fuel Efficiency Graph

The fuel burn and distance data can be analyzed by dividing corresponding fuel consumption numbers with distances traveled. This division will create new data points, Gallons

to the Nautical Mile, which can then be plotted over time. Similarly to the Speed to RPM data, as biofouling accumulates on a ship, the ship will need to spend more fuel to travel a set distance. The trend of this plot is expected to be an increase in the curve's slopes over time, as visualized below in Figure 16. Using the same sliding cleaning interval as mentioned above, it is possible to see how much money can be saved when a new cleaning is set. This is done by redrawing the initial gallon/nautical mile curve trend at the “new” cleaning (the blue line in Figure 16 below), then integrating between the top (actual) and bottom (hypothetical cleaning) curves. This will give you data that can be calculated into total gallons of fuel saved from the implementation of the new cleaning(s), which can then be translated into money saved.
